INVESTIGATION OF THE DURABILITY OF CEMENT DRAIN TILE IN ALKALI SOILS

(CONTAINING RESULTS OF FIRST YEAR'S TESTS)

R. J. WIG, Engineer Physicist
and

ISSUED JULY 22, 1915

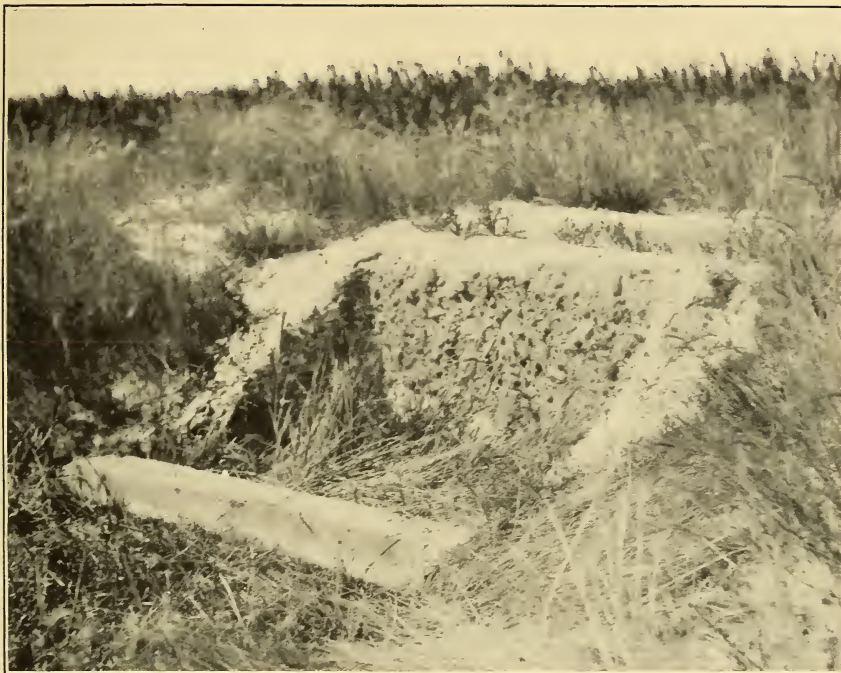
In Fig. 1 is shown a small concrete structure known as a "turn-out" for irrigation water, which was built about 1907. One portion of this structure is completely disintegrated while another portion is sound. The sound portion is a beam on the lower side extending into the wing walls exposed to the earth at each end and located so that half of it is above the concentrated alkali water and half below. The composition of the salts was found to be as follows:

The beam was molded and cured in the yard and set into place in the "turnout" several days later, at the time the turnout was cast. No records were available to show the composition or method of molding, but it was stated that probably the same materials and proportions were used in both parts of the structure. The primary cause of failure of the disintegrated portion may not be the alkali salts, although it would appear that alkali might be responsible. The excellent condition of the beam, however, would demonstrate that concrete can be made which will resist, at least for a number of years, the action of concentrated alkali of the character found at this locality.

FIG. 1.—Concrete "turnout" in alkali soil on abandoned irrigation canal, showing the complete disintegration of one portion of the structure, with a premolded beam in the foreground which is perfectly sound. White appearance of disintegrated portion is caused by the alkali salts which fill the pores

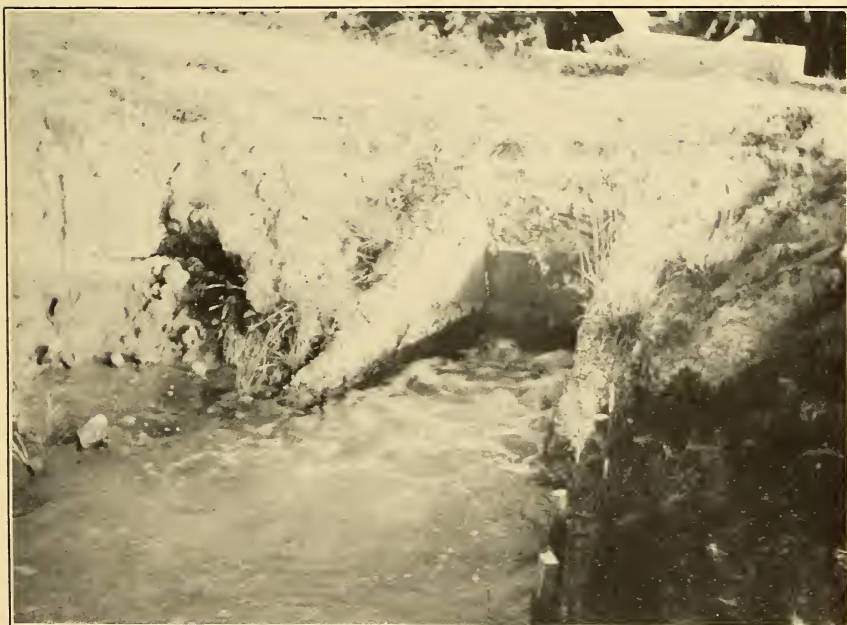
FIG. 2.—Concrete gate culvert in alkali soil on irrigation canal. Note complete disintegration of concrete in foreground while upper end is perfectly sound. White deposit of alkali is visible on the left above the surface of the water

These analyses show no abnormality which would account for the disintegration. The sodium and potassium were not determined, but they were evidently not in excess of 1 per cent. The SO₃, Cl, and MgO were also normal. Therefore it would seem that the failure could not have been caused by the alkali, although no other explanation can be offered without a knowledge of the materials used, method employed, and weather conditions at the time of fabrication. This information is not available.

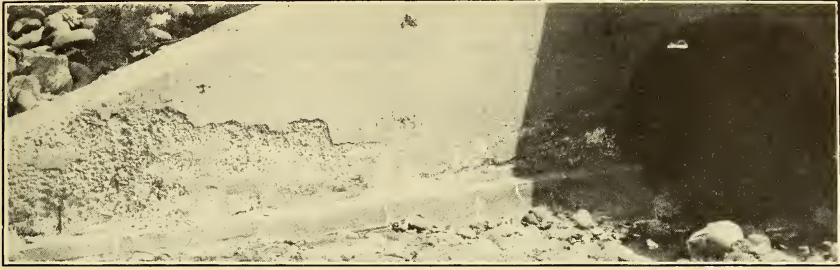
The concrete wing wall of a large culvert shown in Fig. 3 was cited as a case of disintegration due to alkali salts. Upon investigation it was found that there was a bend in the creek at the point where the culvert is located, and during flood the creek carried boulders 12 to 20 inches in diameter which would be thrown against the wall.

Alkali salts are visible in the pores where the surface is eroded to a considerable depth, but the cement and concrete appears hard and the presence of the alkali would seem to be incidental and contributory rather than the initial cause of disintegration. The composition of the alkali salts taken from the surface was as follows:

FIG. 3.—Concrete wing wall of culvert in alkali soil under irrigation canal. Damage attributed to alkali due to appearance of alkali on eroded surface. Initial erosion probably due to impact of large boulders brought down by flood water

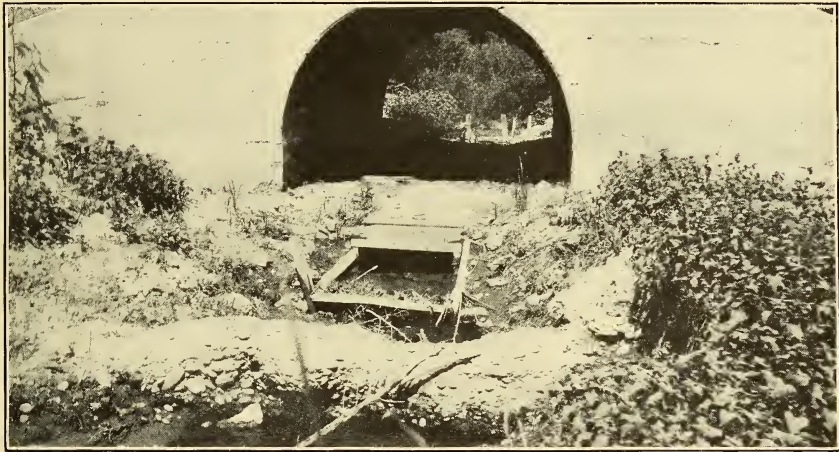
In Fig. 4 is shown a large railroad culvert with a portion of an old concrete structure remaining in the foreground. The concrete remaining from the old structure is completely disintegrated, so that it can be torn apart with the fingers, and alkali salts are found in the pores. The new culvert, which is about eight years old, appears to be sound and normal with the exception of a few spots near the ground line which can be scraped away with a knife. The culvert as a whole does not evidence good workmanship in fabrication.

FIG. 4.—Concrete culvert in alkali soil under railway roadbed. Small mass of concrete in foreground remaining from an earlier structure is completely disintegrated. Present structure shows no effect of alkali action although it is considerably cracked from settlement

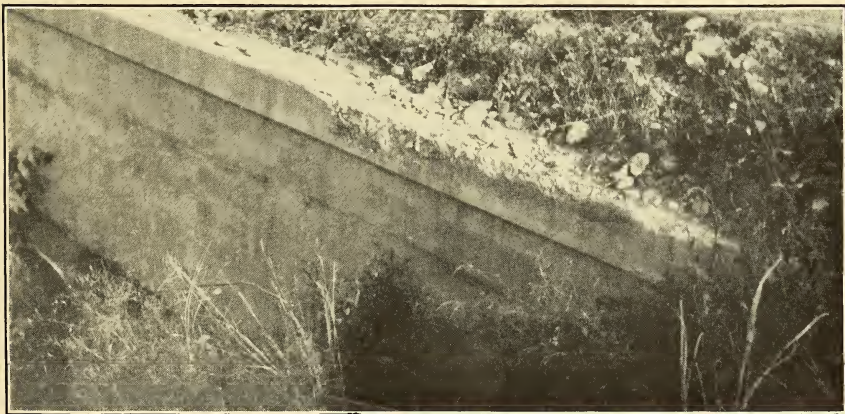
In Fig. 5 is shown a small concrete retaining wall the coping of which is disintegrated and referred to as a failure due to alkali salts. The surface of the soil surrounding this wall, both at the top and along the sides, shows the presence of alkali salts. The wall is sound and hard at all points examined excepting the coping where disintegration is shown. Since structures are found in the East where no alkali salts are present, which appear just as the one shown with the coping sluffed off due to frost action on a very weak section in the concrete that results from the use of watery mixtures, it is quite possible that the disintegration of the coping in this structure is due to that cause. In mixtures in which an excessive amount of water is used the fine material in the aggregate and cement will float to the surface in the forms as they are filled and collect at the top of the form, resulting in a very porous and weak section which is readily attacked by frost.

FIG. 5.—Concrete retaining wall in alkali soil. Alkali salts are visible in the surrounding soil. There is no disintegration of concrete in lower section just above water level, where it usually occurs. Disintegrated coping is probably due to use of excess of water in concrete at time of placing

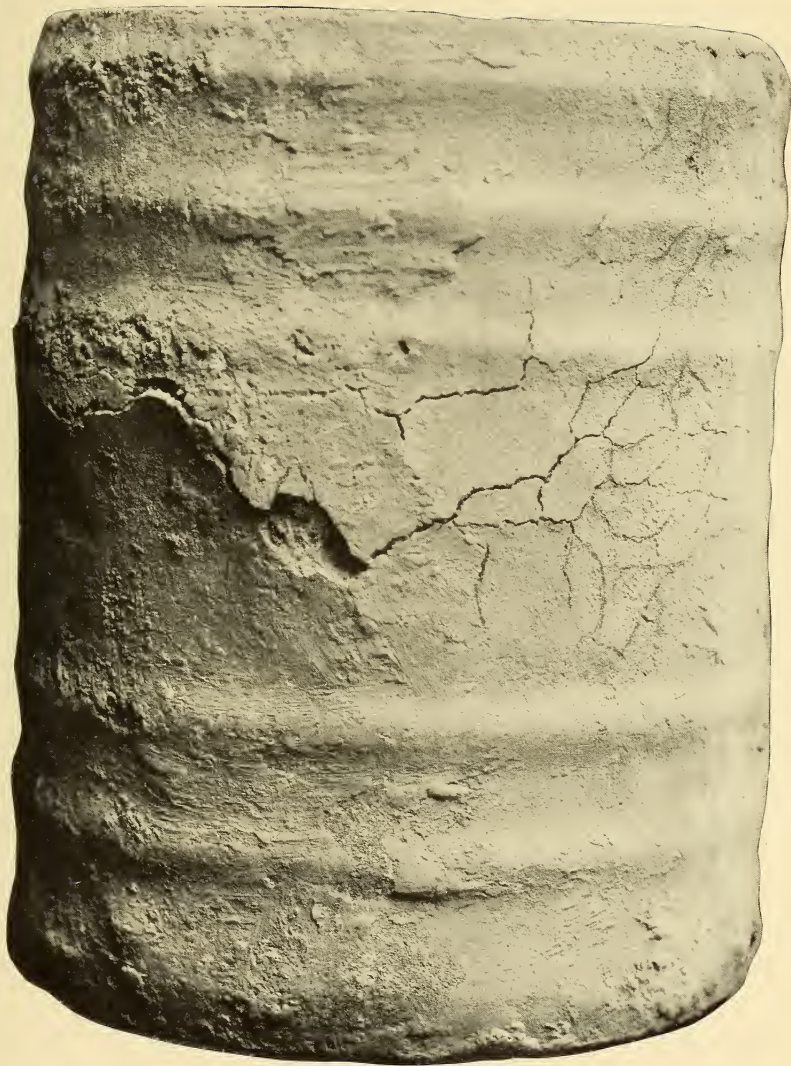
FIG. 50.—Swollen and cracked tile of series 16 after one year's exposure at Grand Junction, Colo. The interior surface is cracked similar to the exterior
